**Flood Control Project Maintenance
Levee Inspections**

Fall 2018 Levee Maintenance Deficiency Summary Report

San Joaquin River Basin

Reclamation District No. 2062 Stewart

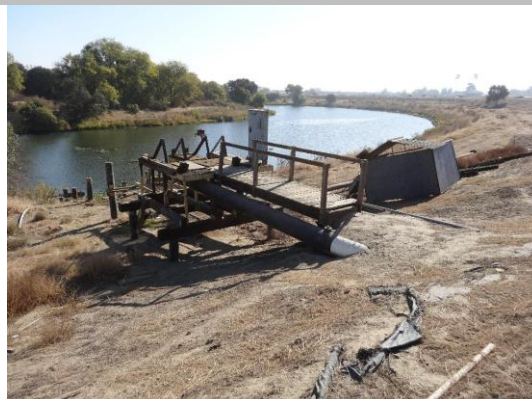
Photo 1 of 3 : UCIP_FA_2018_22807_38905.jpg

Comment Code						
Inspector Comment						
FS_ID:22807 DS_ID:19177 EP_NO: 12679 Repair Type: Non-Urgent Crossing Status: Found UCIP Comments: - All 3 pipes on landside looks new.- Pumps, pump house, and pipes removed from waterside.- Land development activities going on in this area.- Needs to confirm from LMA or DWR Inspector about the crossing. FIELD_STRUCT_DESC: 1 of 3: 16-inch steel irrigation discharge pipe through the levee, 5 feet below the crown. Electrical conduit through the levee. Slant pump in a pump house on the waterside (WS) slope. Siphon breaker on the landside (LS) slope. Service pole and concrete gate valve box at the landside (LS) toe. Installed by USACE in 1961. (Plans to replace rusted portions of two 16-inch irrigation pipes through the levee authorized under Permit No. 16124, 1993 - Reclamation District No. 2062). [Additional Reference(s): DWR Levee Log, 2007. USACE San Joaquin O&M Manual 9, April 1964, (HLM 1.65)]. FS Date: 10/22/2013

WS view: pipes, walkway, and dismantled pump house (right).

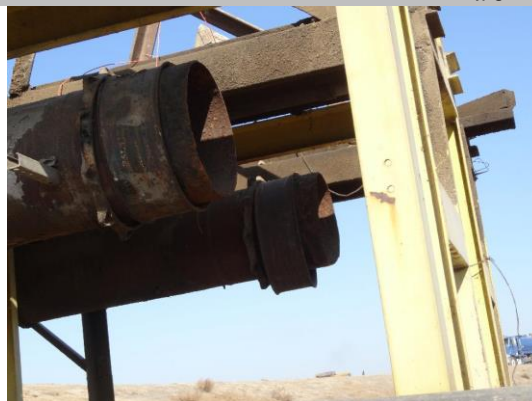
Photo 3 of 3 : UCIP_FA_2018_22807_38903.jpg

Comment Code						
Inspector Comment						
FS_ID:22807 DS_ID:19177 EP_NO: 12679 Repair Type: Non-Urgent Crossing Status: Found UCIP Comments: - All 3 pipes on landside looks new.- Pumps, pump house, and pipes removed from waterside.- Land development activities going on in this area.- Needs to confirm from LMA or DWR Inspector about the crossing. FIELD_STRUCT_DESC: 1 of 3: 16-inch steel irrigation discharge pipe through the levee, 5 feet below the crown. Electrical conduit through the levee. Slant pump in a pump house on the waterside (WS) slope. Siphon breaker on the landside (LS) slope. Service pole and concrete gate valve box at the landside (LS) toe. Installed by USACE in 1961. (Plans to replace rusted portions of two 16-inch irrigation pipes through the levee authorized under Permit No. 16124, 1993 - Reclamation District No. 2062). [Additional Reference(s): DWR Levee Log, 2007. USACE San Joaquin O&M Manual 9, April 1964, (HLM 1.65)]. FS Date: 10/22/2013

WS view: two 16-inch pipes. Pumps were removed. Pumphouse dismantled.

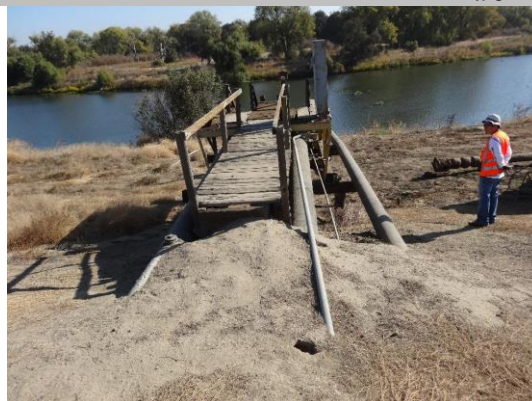
Photo 2 of 3 : UCIP_FA_2018_22809_38912.jpg

Comment Code						
Inspector Comment						
FS_ID:22809 DS_ID:19183 EP_NO: 12679 Repair Type: Non-Urgent Crossing Status: Found UCIP Comments: - All 3 pipes on landside looks new.- Pumps, pump house, and pipes removed from waterside.- Land development activities going on in this area.- Needs to confirm from LMA or DWR Inspector about the crossing. FIELD_STRUCT_DESC: 2 of 3: 16-inch steel irrigation discharge pipe through the levee, 5 feet below the crown. Electrical conduit through the levee. Slant pump in a pump house on the waterside (WS) slope. Siphon breaker on the landside (LS) slope. Service pole and concrete gate valve box at the landside (LS) toe. Installed by USACE in 1961. (Plans to replace rusted portions of two 16-inch irrigation pipes through the levee authorized under Permit No. 16124, 1993 - Reclamation District No. 2062). [Additional Reference(s): DWR Levee Log, 2007. USACE San Joaquin O&M Manual 9, April 1964, (HLM 1.65)]. FS Date: 10/22/2013

WS view: 16-inch pipes on both sides of walkway and 10-inch pipe (on right) away from walkway.

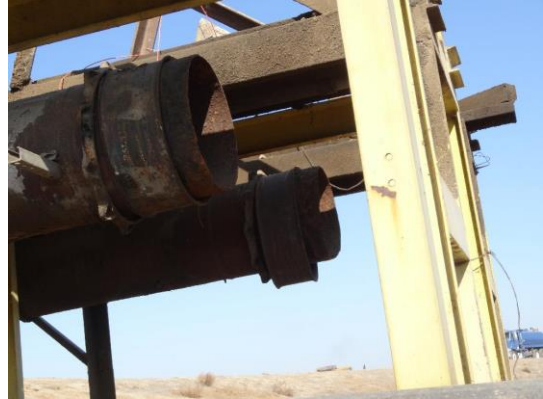
Photo 3 of 3 : UCIP_FA_2018_22809_38911.jpg

Comment Code						
Inspector Comment						
FS_ID:22809 DS_ID:19183 EP_NO: 12679 Repair Type: Non-Urgent Crossing Status: Found UCIP Comments: - All 3 pipes on landside looks new.- Pumps, pump house, and pipes removed from waterside.- Land development activities going on in this area.- Needs to confirm from LMA or DWR Inspector about the crossing. FIELD_STRUCT_DESC: 2 of 3: 16-inch steel irrigation discharge pipe through the levee, 5 feet below the crown. Electrical conduit through the levee. Slant pump in a pump house on the waterside (WS) slope. Siphon breaker on the landside (LS) slope. Service pole and concrete gate valve box at the landside (LS) toe. Installed by USACE in 1961. (Plans to replace rusted portions of two 16-inch irrigation pipes through the levee authorized under Permit No. 16124, 1993 - Reclamation District No. 2062). [Additional Reference(s): DWR Levee Log, 2007. USACE San Joaquin O&M Manual 9, April 1964, (HLM 1.65)]. FS Date: 10/22/2013

WS view: two 16-inch pipes under walkway; pumps were removed.

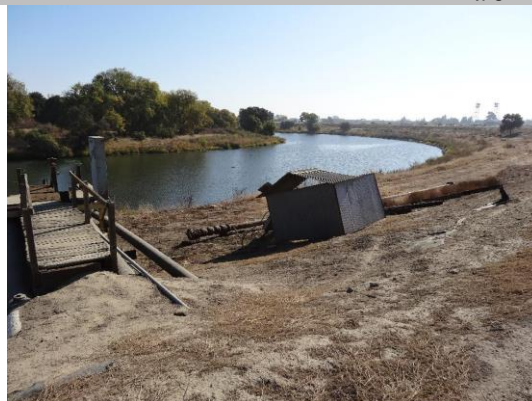
Photo 2 of 3 : UCIP_FA_2018_22810_38917.jpg

Comment Code						
Inspector Comment						
FS_ID:22810 DS_ID:19184 EP_NO: 12679 Repair Type: Non-Urgent Crossing Status: Found UCIP Comments: - All 3 pipes on landside looks new. No pump associated with 8-inch pipe.- Pumps, pump house, and pipes removed from waterside.- Land development activities going on in this area.- Needs to confirm from LMA or DWR Inspector about the crossing. FIELD_STRUCT_DESC: 3 of 3: 8-inch steel irrigation discharge pipe through the levee, 8 feet below the crown. Electrical conduit through the levee. Slant pump in a pump house on the waterside (WS) slope. Siphon breaker on the landside (LS) slope. Service pole and concrete gate valve box at the landside (LS) toe. (Plans to install a 75-horsepower pump on the bank with a 10-inch steel discharge pipe through the levee authorized under Permit No. 12679, 1979 - Reclamation District No. 2062). [Additional Reference(s): DWR Levee Log, 2007]. FS Date: 10/22/2013

WS view: electric conduit and 10-inch pipe (right). Dismantled/removed pipe and pump house (far right).

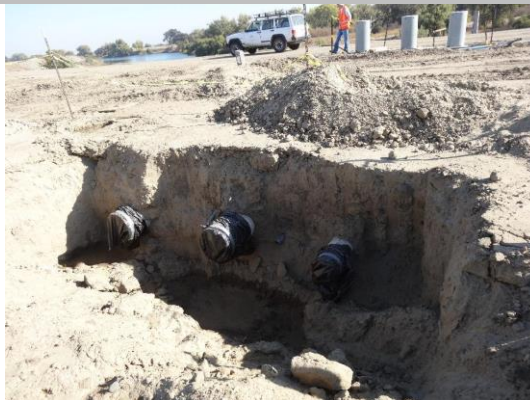
Photo 3 of 3 : UCIP_FA_2018_22810_38916.jpg

Comment Code						
Inspector Comment						
FS_ID:22810 DS_ID:19184 EP_NO: 12679 Repair Type: Non-Urgent Crossing Status: Found UCIP Comments: - All 3 pipes on landside looks new. No pump associated with 8-inch pipe.- Pumps, pump house, and pipes removed from waterside.- Land development activities going on in this area.- Needs to confirm from LMA or DWR Inspector about the crossing. FIELD_STRUCT_DESC: 3 of 3: 8-inch steel irrigation discharge pipe through the levee, 8 feet below the crown. Electrical conduit through the levee. Slant pump in a pump house on the waterside (WS) slope. Siphon breaker on the landside (LS) slope. Service pole and concrete gate valve box at the landside (LS) toe. (Plans to install a 75-horsepower pump on the bank with a 10-inch steel discharge pipe through the levee authorized under Permit No. 12679, 1979 - Reclamation District No. 2062). [Additional Reference(s): DWR Levee Log, 2007]. FS Date: 10/22/2013

LS view: two 16-inch pipes (left) and one 10-inch pipe (right) in ditch. Concrete box removed.

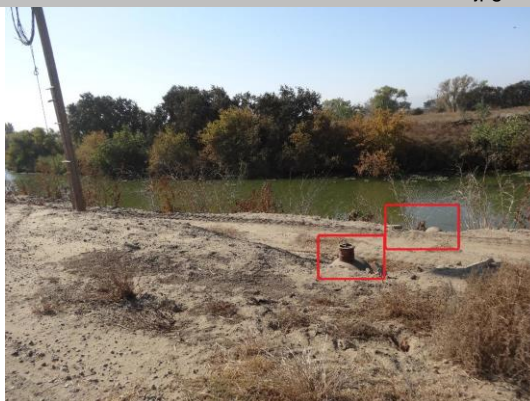
Photo 1 of 3 : UCIP_FA_2018_23110_39398.jpg

LM Start	0.56	Rating **	M	Issue No.	16	
LM End	0.56	Issue Type +	En	Location *		
Category	Supplemental			GPS Latitude/Longitude		
				Start	End	
Item	DWR UCIP Field Study			37.784380 °	37.784380 °	
				-121.338985 °	-121.338985 °	
DWR ID	24697					
Comment Code						
Inspector Comment						
FS_ID:23110						
DS_ID:24697						
EP_NO: N/A						
Repair Type: Non-Urgent						
Crossing Status: Found						
UCIP Comments: Found on field with the help of USACE 2012 PI						
Report.Needs proper abandonment.						
FIELD_STRUCT_DESC: *ABANDONED* 24-inch steel irrigation						
discharge pipe through the levee, at an unknown depth. Damaged						
siphon breaker on the waterside (WS) slope. Pump on a concrete sump						
in an irrigation ditch on the landside (LS). Service pole on the LS slope.						
Pump disconnected from the service pole.						
FS Date: 10/23/2013

WS view: power pole (left), siphon breaker (marked- left), and steel pipe (right) on levee slope.

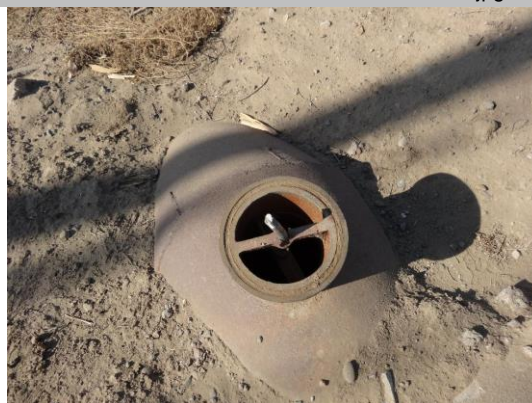
Photo 2 of 3 : UCIP_FA_2018_23110_39397.jpg

LM Start	0.56	Rating **	M	Issue No.	16 (cont)	
LM End	0.56	Issue Type +	En	Location *		
Category	Supplemental			GPS Latitude/Longitude		
				Start		End
Item	DWR UCIP Field Study			37.784380 °		37.784380 °
				-121.338985 °		-121.338985 °
DWR ID	24697					
Comment Code						
Inspector Comment						
FS_ID:23110 DS_ID:24697 EP_NO: N/A Repair Type: Non-Urgent Crossing Status: Found UCIP Comments: Found on field with the help of USACE 2012 PI Report.Needs proper abandonment. FIELD_STRUCT_DESC: *ABANDONED* 24-inch steel irrigation discharge pipe through the levee, at an unknown depth. Damaged siphon breaker on the waterside (WS) slope. Pump on a concrete sump in an irrigation ditch on the landside (LS). Service pole on the LS slope. Pump disconnected from the service pole. FS Date: 10/23/2013

WS view: exposed steel pipe and damaged siphon breaker on levee slope.

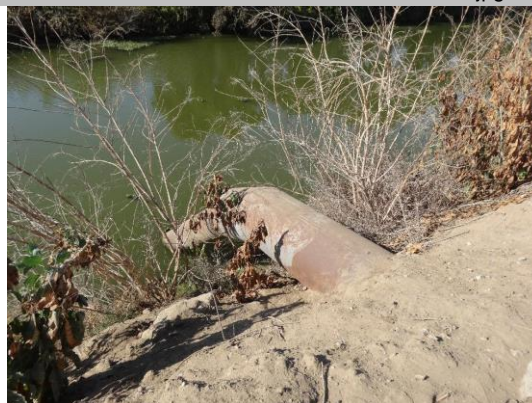
Photo 3 of 3 : UCIP_FA_2018_23110_39396.jpg

WS view: exposed steel pipe on channel bank and also immersed into channel water.

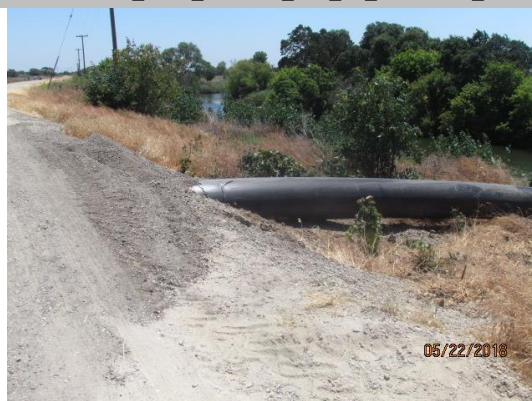
Photo 2 of 4 : FA_2018_RD2062_310_15_20180906_00008.jpg

Looking northeast at pipes on waterward slope. (Spring 2018)

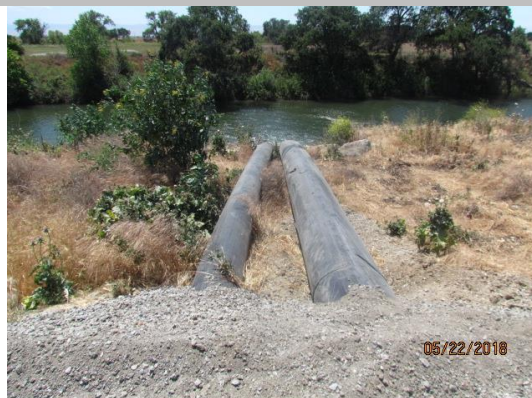
Photo 3 of 4 : FA_2018_RD2062_310_15_20180906_00009.jpg

Looking east at pipes on waterward slope. (Spring 2018)

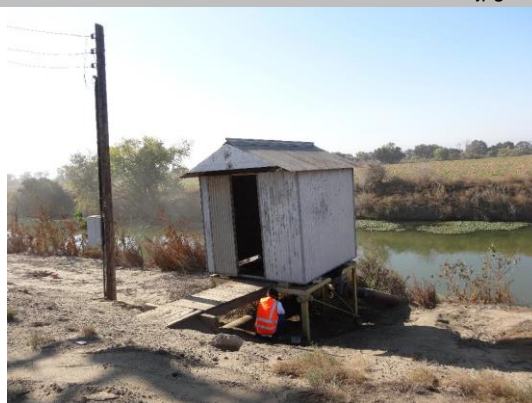
Photo 1 of 3 : UCIP_FA_2018_23181_39792.jpg

Comment Code						
Inspector Comment						
FS_ID:23181 DS_ID:19192 EP_NO: 12427 Repair Type: Non-Urgent Crossing Status: Found UCIP Comments: - no siphon breaker found- levee toe erosion under walkway on waterside.- erosion around concrete standpipe on landside- may be base of the standpipe was leaking. FIELD_STRUCT_DESC: 18-inch irrigation discharge pipe of an unknown material through the levee, 4.4 feet below the crown. Pump house on the waterside (WS) slope. Metal walkway from the pump house to the crown. Service pole on the WS. Flap gate, siphon breaker, and concrete distribution box on the landside (LS) slope. (Emergency plans to replace an existing 18-inch discharge pipe through the levee authorized under Permit No. 12427, 1978 - Reclamation District No. 2062). [Additional Reference(s): DWR Levee Log, 2007, 16-inch pipe referenced. USACE San Joaquin O&M Manual 9, April 1964, (HLM 0.76)]. FS Date: 10/23/2013

WS view: pipe, walkway, service pole, and pump house on levee slope.

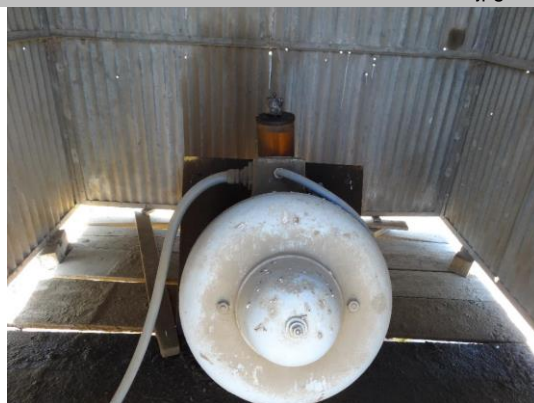
Photo 2 of 3 : UCIP_FA_2018_23181_39791.jpg

FS_ID:23181
DS_ID:19192
EP_NO: 12427
Repair Type: Non-Urgent
Crossing Status: Found
UCIP Comments: - no siphon breaker found- levee toe erosion under walkway on waterside.- erosion around concrete standpipe on landside- may be base of the standpipe was leaking.
FIELD_STRUCT_DESC: 18-inch irrigation discharge pipe of an unknown material through the levee, 4.4 feet below the crown. Pump house on the waterside (WS) slope. Metal walkway from the pump house to the crown. Service pole on the WS. Flap gate, siphon breaker, and concrete distribution box on the landside (LS) slope. (Emergency plans to replace an existing 18-inch discharge pipe through the levee authorized under Permit No. 12427, 1978 - Reclamation District No. 2062). [Additional Reference(s): DWR Levee Log, 2007, 16-inch pipe referenced. USACE San Joaquin O&M Manual 9, April 1964, (HLM 0.76)].
FS Date: 10/23/2013

WS view: leaky slant pump in pump house on levee slope.

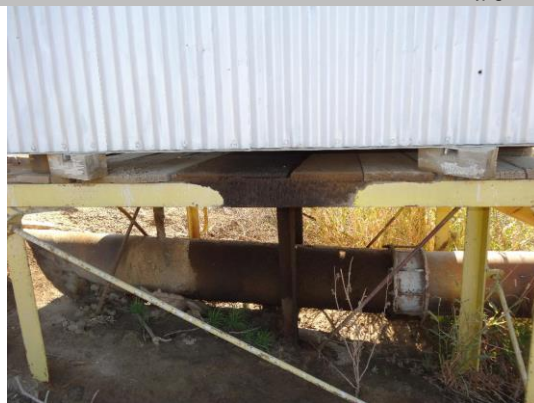
Photo 3 of 3 : UCIP_FA_2018_23181_39790.jpg

WS view: oil leakage from slant pump. Pipe under pump house.

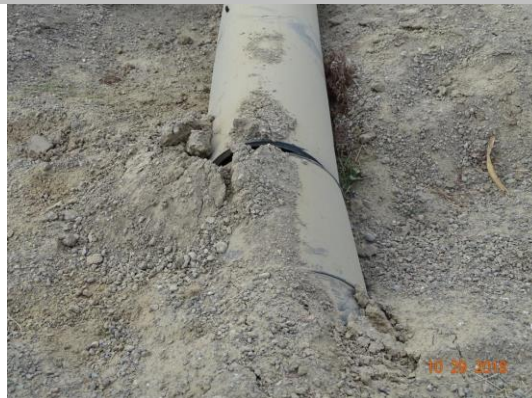
Photo 1 of 5 : FA_2018_RD2062_310_14_20181101_00035.jpg

Looking at broken pipe on waterward slope. (Fall 2018)

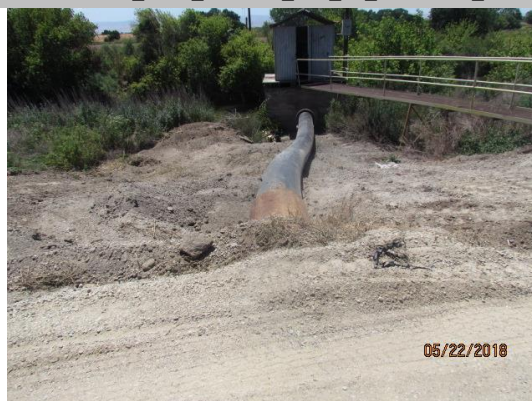
Photo 2 of 5 : FA_2018_RD2062_310_14_20180906_00003.jpg

Looking east at pump house and pipe on waterward slope. (Spring 2018)

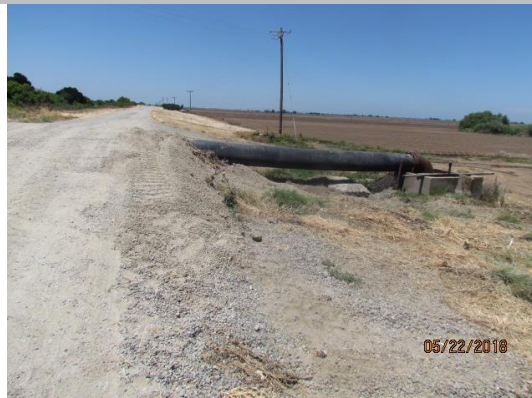
Photo 3 of 5 : FA_2018_RD2062_310_14_20180906_00004.jpg

Looking south at installation (pipe) on landward slope. (Spring 2018)

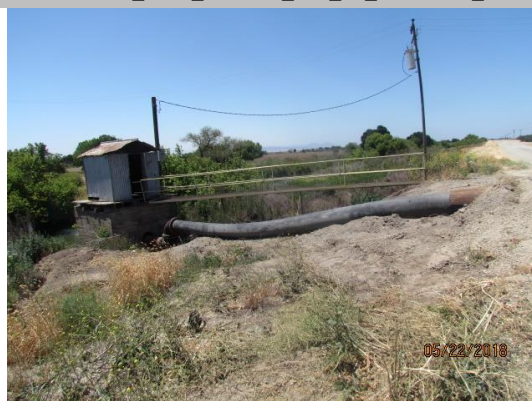
Photo 5 of 5 : FA_2018_RD2062_310_14_20180906_00006.jpg

Looking south at installation (pipe) on waterward slope. (Spring 2018)

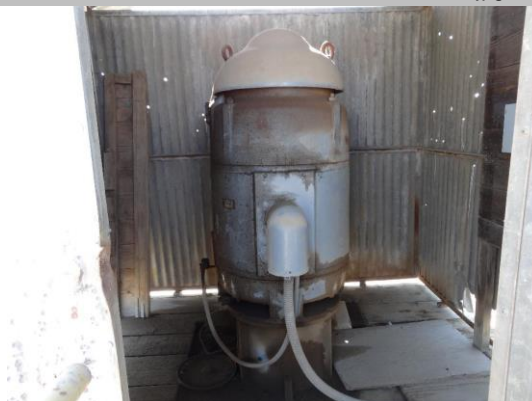
Photo 2 of 3 : UCIP_FA_2018_51468_39194.jpg

Comment Code						
Inspector Comment						
FS_ID:51468 DS_ID:19193 EP_NO: N/A Repair Type: Non-Urgent Crossing Status: Found UCIP Comments: 04/05/2017:Pipe has been plugged as a flood fight measure and is likely to be replaced under a permit. MBK (Michael Moncrief) is working on the permit. Photo and update courtesy of Max Khashchuk as part of his 2017 Spring Inspection. (K. Fazel - UCIP)10/22/2013:- pumphouse on concrete sump in the channel.- erosion under walkway on waterside. (P. Amatya - DWR) FIELD_STRUCT_DESC: 20-inch steel irrigation discharge pipe through the levee, 8 feet below the crown. Pump house on the waterside (WS) slope. Metal walkway from the pump house to the crown. Flap gate, siphon breaker, and concrete distribution box on the landside (LS) slope. [Additional Reference(s): DWR Levee Log, 2007, 18-inch pipe referenced. USACE San Joaquin O&M Manual 9, April 1964, (HLM 1.40), 18-inch pipe referenced]. FS Date: 4/6/2017

WS view: leaky pump and control box in pumphouse.

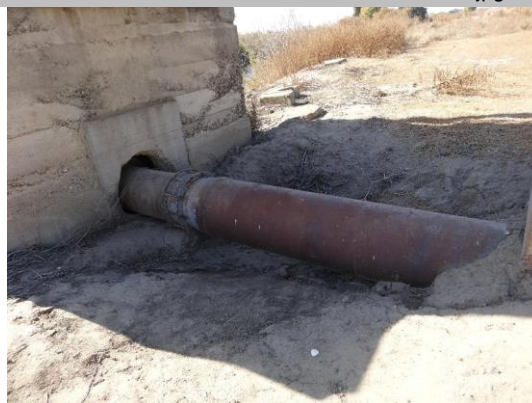
Photo 3 of 3 : UCIP_FA_2018_51468_39193.jpg

Comment Code						
Inspector Comment						
FS_ID:51468 DS_ID:19193 EP_NO: N/A Repair Type: Non-Urgent Crossing Status: Found UCIP Comments: 04/05/2017:Pipe has been plugged as a flood fight measure and is likely to be replaced under a permit. MBK (Michael Moncrief) is working on the permit. Photo and update courtesy of Max Khashchuk as part of his 2017 Spring Inspection. (K. Fazel - UCIP)10/22/2013:- pumphouse on concrete sump in the channel.- erosion under walkway on waterside. (P. Amatya - DWR) FIELD_STRUCT_DESC: 20-inch steel irrigation discharge pipe through the levee, 8 feet below the crown. Pump house on the waterside (WS) slope. Metal walkway from the pump house to the crown. Flap gate, siphon breaker, and concrete distribution box on the landside (LS) slope. [Additional Reference(s): DWR Levee Log, 2007, 18-inch pipe referenced. USACE San Joaquin O&M Manual 9, April 1964, (HLM 1.40), 18-inch pipe referenced]. FS Date: 4/6/2017

WS view: exposed steel pipe under walkway. Soil erosion under walkway. This may be due to leaky pipe joint.

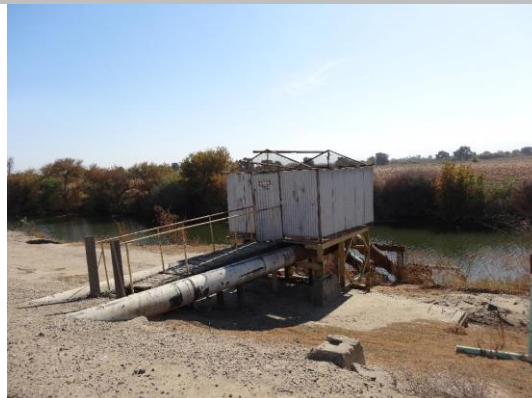
Photo 1 of 3 : UCIP_FA_2018_53375_39187.jpg

FS_ID:53375
DS_ID:19194
EP_NO: 4305
Repair Type: Urgent
Crossing Status: Found
UCIP Comments: 10/10/2018 Extremely overgrown vegetation did not allow visual inspection of WS levee erosion; however, there are indications based on vegetation growth patterns that the erosion is still present, so keeping crossing as Urgent (D. Sanoski - DWR UCIP).08/31/2016: Heavy sloughing and sink hole remains at the WS slope in alignment with pipe. Though sloughing is not affecting levee prism, it is still an indication of a pipe integrity problem. Oil leak at the pump but does not appear to impact the levee. (K. Fazel - UCIP)10/22/2013:- missing roof in pump house.- no protection for siphon breaker- huge erosion under pumphouse and levee slope on waterside. (P. Amatya - DWR)
FIELD_STRUCT_DESC: 1 of 2: 18-inch steel irrigation discharge pipe through the levee, 4.8 feet below the crown. Pump house on the waterside (WS) slope. Siphon breaker on the landside (LS) shoulder. Service pole on the LS shoulder. Concrete distribution box at the LS toe. (Plans for installation of two irrigation pumps on the bank to replace an old centrifugal pumping plant at the same location authorized under Permit No. 4305, 1963 - Reclamation District No. 2062) [Additional Reference(s): DWR Levee Log, 2007. USACE San Joaquin O&M Manual 9, April 1964, (HLM 1.67)].

WS view: pipes, walkway, and pumphouse with missing roof (right).

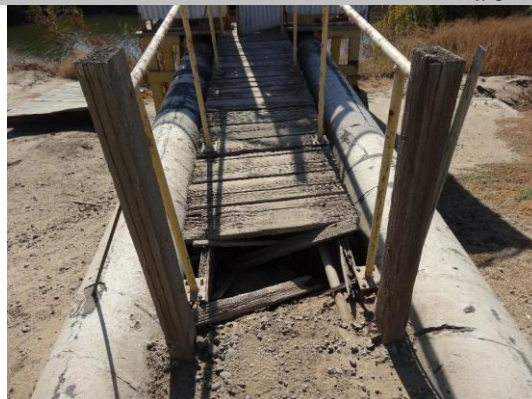
Photo 2 of 3 : UCIP_FA_2018_53375_39186.jpg

WS view: walkway to pumphouse. Walkway in poor condition.

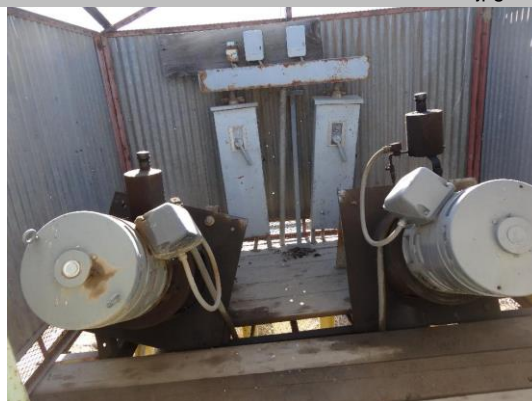
Photo 3 of 3 : UCIP_FA_2018_53375_39185.jpg

Comment Code						
Inspector Comment						
FS_ID:53375 DS_ID:19194 EP_NO: 4305 Repair Type: Urgent Crossing Status: Found UCIP Comments: 10/10/2018 Extremely overgrown vegetation did not allow visual inspection of WS levee erosion; however, there are indications based on vegetation growth patterns that the erosion is still present, so keeping crossing as Urgent (D. Sanoski - DWR UCIP).08/31/2016: Heavy sloughing and sink hole remains at the WS slope in alignment with pipe. Though sloughing is not affecting levee prism, it is still an indication of a pipe integrity problem. Oil leak at the pump but does not appear to impact the levee. (K. Fazel - UCIP)10/22/2013:- missing roof in pump house.- no protection for siphon breaker- huge erosion under pumphouse and levee slope on waterside. (P. Amatya - DWR) FIELD_STRUCT_DESC: 1 of 2: 18-inch steel irrigation discharge pipe through the levee, 4.8 feet below the crown. Pump house on the waterside (WS) slope. Siphon breaker on the landside (LS) shoulder. Service pole on the LS shoulder. Concrete distribution box at the LS toe. (Plans for installation of two irrigation pumps on the bank to replace an old centrifugal pumping plant at the same location authorized under Permit No. 4305, 1963 - Reclamation District No. 2062) [Additional Reference(s): DWR Levee Log, 2007. USACE San Joaquin O&M Manual 9, April 1964, (HLM 1.67)]. FS Date: 10/10/2018 11:02:00 AM

WS view: two leaky slant pumps in pumphouse with missing roof.

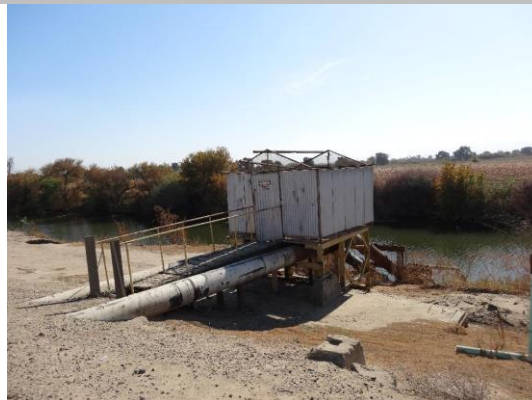
Photo 1 of 3 : UCIP_FA_2018_53376_39176.jpg

FS_ID:53376
DS_ID:19197
EP_NO: 4305
Repair Type: Urgent
Crossing Status: Found
UCIP Comments: 10/10/2018 Extremely overgrown vegetation did not allow visual inspection of WS levee erosion; however, there are indications based on vegetation growth patterns that the erosion is still present, so keeping crossing as Urgent (D. Sanoski - DWR UCIP).08/31/2016: Heavy sloughing and sink hole remains at the WS slope in alignment with pipes. Though sloughing is not affecting levee prism, it is still an indication of a pipe integrity problem. Oil leak at the pump but does not appear to impact levee. (K. Fazel - UCIP)10/22/2013:- missing roof in pump house.- no protection for siphon breaker- huge erosion under pumphouse and levee slope on waterside. (P. Amatya - DWR)
FIELD_STRUCT_DESC: 2 of 2: 18-inch steel irrigation discharge pipe through the levee, 4.8 feet below the crown. Pump house on the waterside (WS) slope. Siphon breaker on the landside (LS) shoulder. Service pole on the LS shoulder. Concrete distribution box at the LS toe. (Plans for installation of two irrigation pumps on the bank to replace an old centrifugal pumping plant at the same location authorized under Permit No. 4305, 1963 - Reclamation District No. 2062) [Additional Reference(s): DWR Levee Log, 2007. USACE San Joaquin O&M Manual 9, April 1964, (HLM 1.67)].

WS view: pipes, walkway, and pumphouse with missing roof (right).

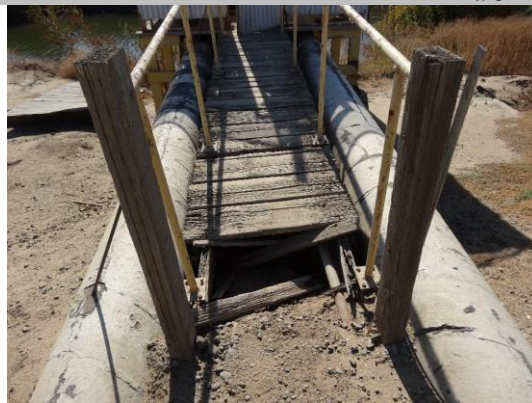
Photo 2 of 3 : UCIP_FA_2018_53376_39175.jpg

WS view: walkway in poor condition, to pumphouse.

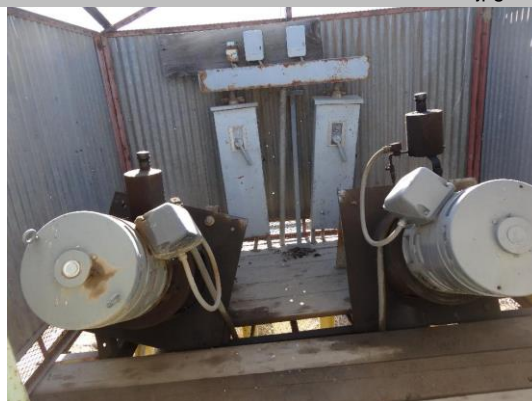
Photo 3 of 3 : UCIP_FA_2018_53376_39174.jpg

WS view: two leaky slant pumps in pumphouse with missing roof.

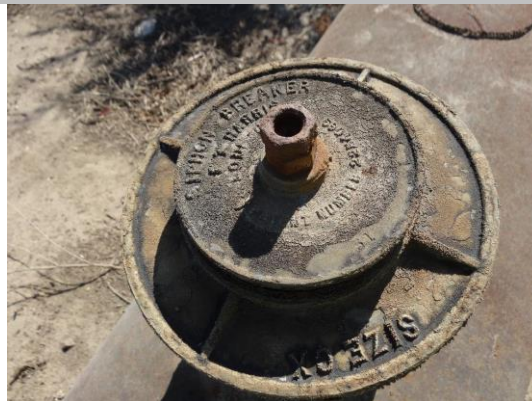
Photo 2 of 3 : UCIP_FA_2018_23304_40146.jpg

WS view: leaky siphon breaker on levee slope.

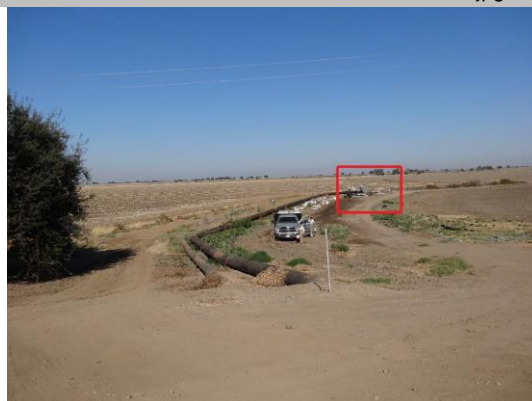
Photo 3 of 3 : UCIP_FA_2018_23304_40148.jpg

LS view: overview of pipes on levee berm and pump platform (marked - right) off the berm 350 ft from the levee.

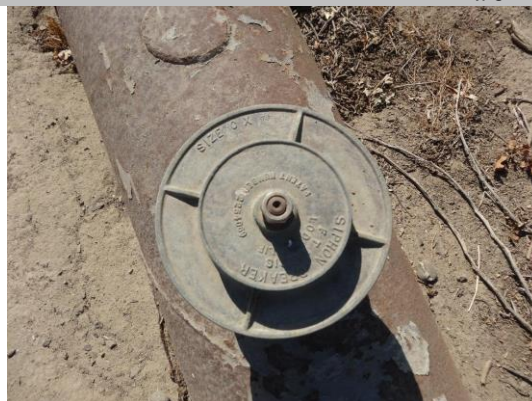
Photo 2 of 3 : UCIP_FA_2018_23023_39081.jpg

WS view: closer view of 18-inch pipe with siphon breaker on levee slope.

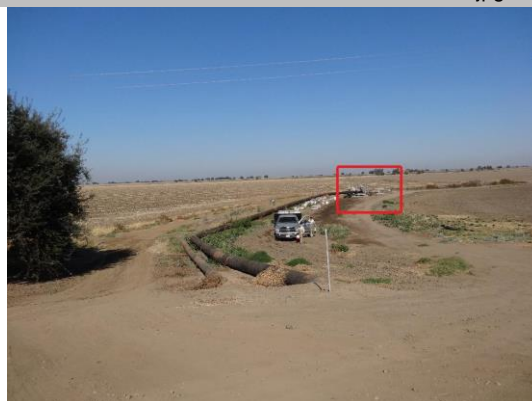
Photo 3 of 3 : UCIP_FA_2018_23023_39080.jpg

LS view: overview of exposed pipes and pump station (marked- right) 350 ft from levee center.

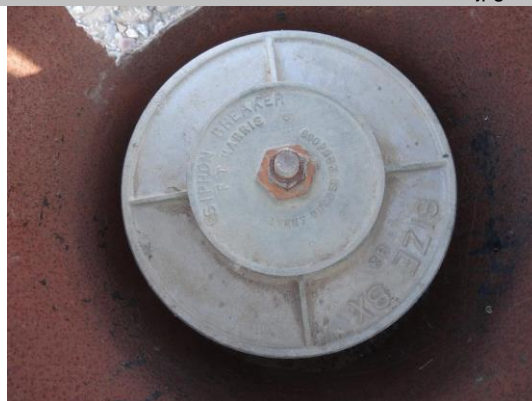
Photo 2 of 3 : UCIP_FA_2018_23305_40152.jpg

WS view: closer view of siphon breaker in steel pipe riser on levee slope.

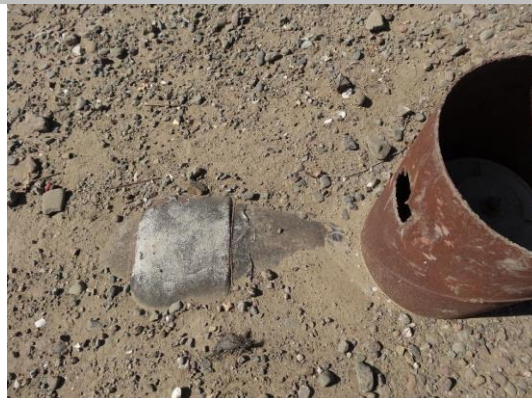
Photo 3 of 3 : UCIP_FA_2018_23305_40151.jpg

WS view: exposed pipe and steel pipe riser on levee slope.

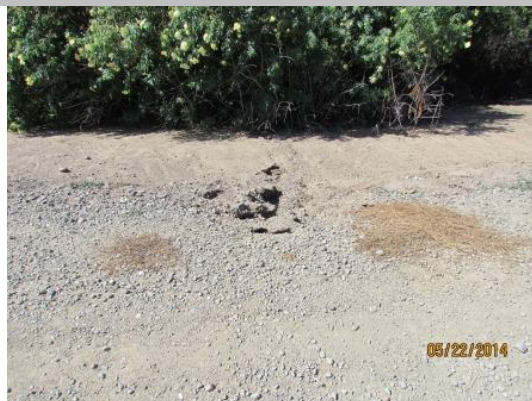
Photo 1 of 1 : FA_2018_RD2062_310_8_20180906_00001.jpg

View of the erosion from surface runoff on the waterside levee slope.

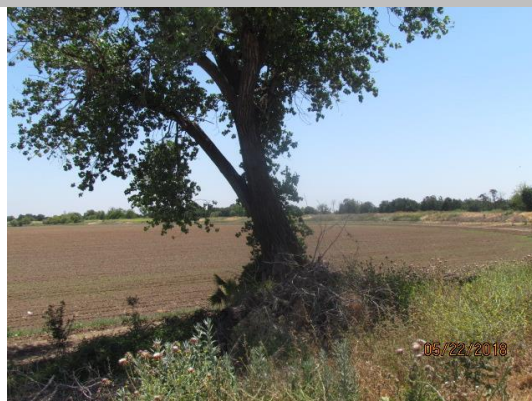
Photo 1 of 1 : FA_2018_RD2062_310_12_20180906_00002.jpg

Looking at broken tree branch on landward slope. (Spring 2018)

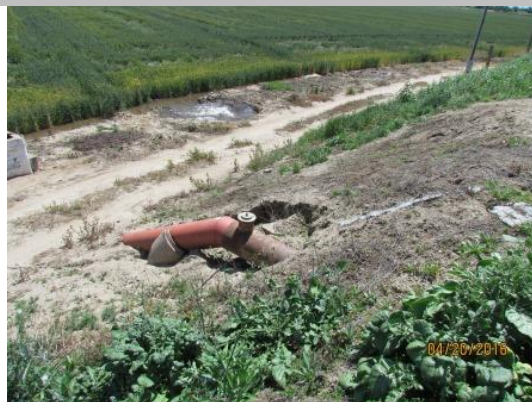
Photo 1 of 1 : FA_2018_RD2062_311_38_20180906_00039.jpg

View of the landside levee slope erosion around the pipe.

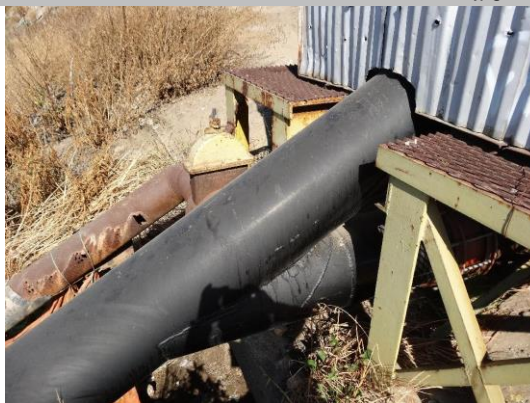
Photo 2 of 3 : UCIP_FA_2018_53377_40157.jpg

WS view: pump house on levee slope and holes/pits on corroded overflow pipe (left).

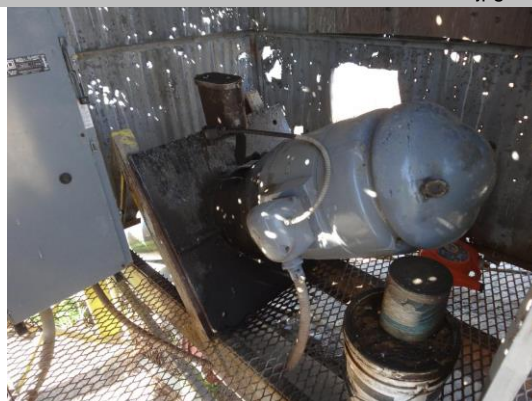
Photo 3 of 3 : UCIP_FA_2018_53377_40156.jpg

WS view: slant pump in pump house on levee slope.

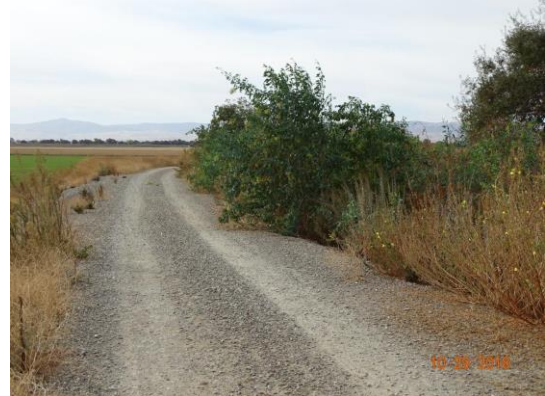
Looking west at dense veg. on waterward slope. (Fall 2018)

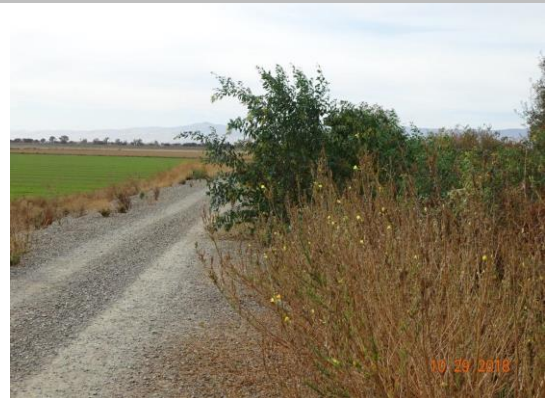
Looking southwest at dense veg (Tabacco plant) on waterward slope.
(Fall 2018)

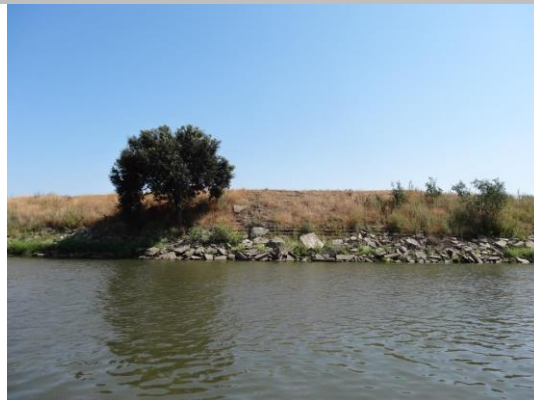
Photo 3 of 4 : FA_2018_RD2062_311_9_20180906_00027.jpg

Front view of the site. Note the existing broken concrete on levee slope and at the levee toe.

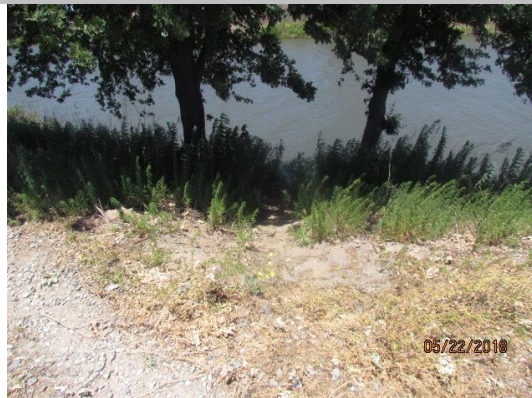
Photo 1 of 1 : FA_2018_RD2062_311_20_20180906_00034.jpg

Looking west at slope damage (foot traffic) on waterward slope. (Spring 2018)

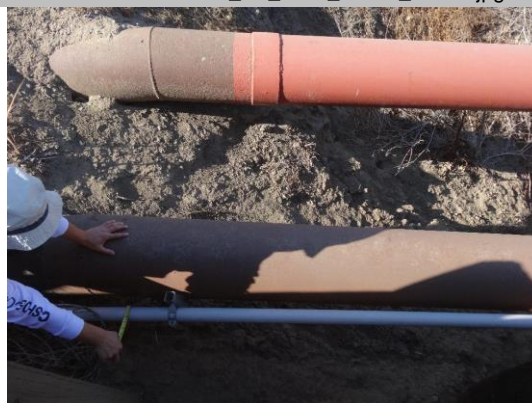
Photo 2 of 3 : UCIP_FA_2018_23312_40179.jpg

WS view: exposed steel pipes and a electric conduit on levee slope.

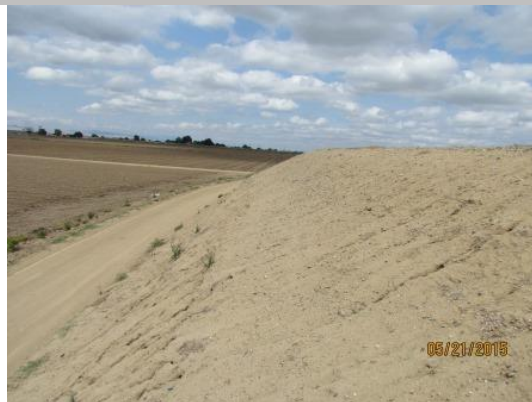
Photo 1 of 1 : FA_2018_RD2062_311_31_20180906_00036.jpg

View of the eroded landside levee toe.

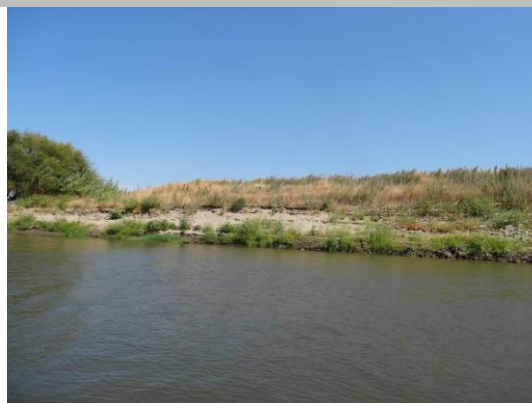
Photo 1 of 3 : FA_2018_RD2062_311_10_20180906_00029.jpg

Front view of the erosion located at the inside of a sharp river bend.

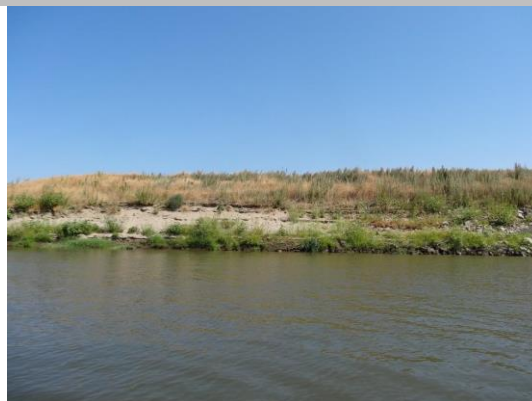
Photo 2 of 3 : FA_2018_RD2062_311_10_20180906_00030.jpg

Close view of the erosion.

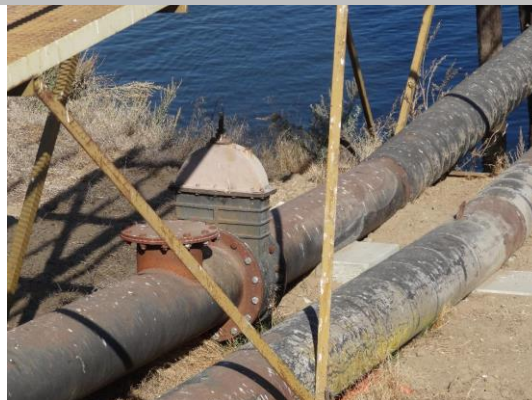
Photo 2 of 3 : UCIP_FA_2018_23142_39548.jpg

WS view: two 16-inch pipes under walkway. Gate valve without handle on one of the pipes.
